Damage Survey and Assessment of Fort Worth Tornado, 28 March 2000

Prepared By
C.W. Letchford, H.S. Norville, and J. Bilello
Wind Science & Engineering Program
Texas Tech University

Submitted to
National Institute for Standards and Technology
August 2000

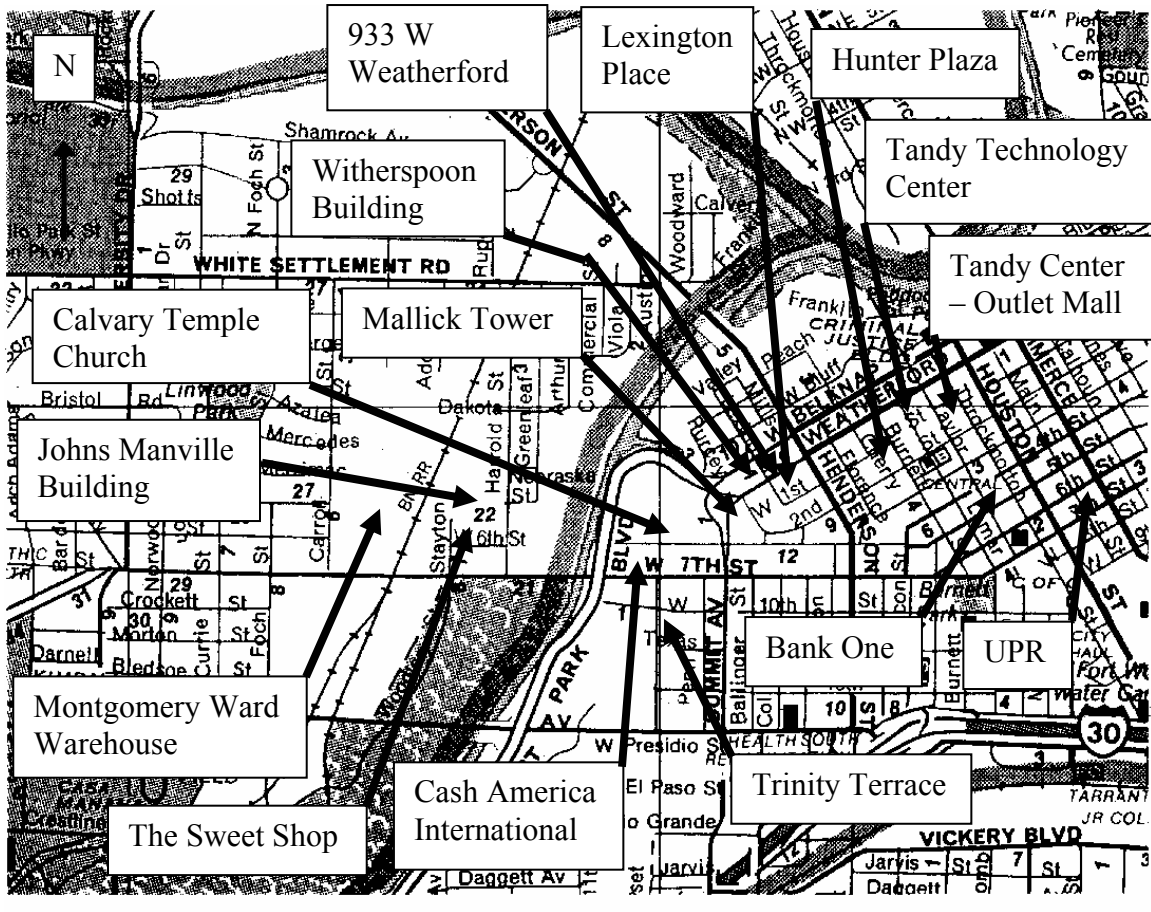
The major buildings damaged in the Fort Worth tornado are shown on the map in Figure 5, with a more detailed map of the downtown in Figure 6. The damage documentation team surveyed the general damage area on the eastern side of the Trinity River on March 30 in two groups, and several buildings were documented in detail. The western side of the Trinity River was documented on March 31 as a single team.

Figure 5. Map of the region affected by the tornado showing the major buildings damaged.

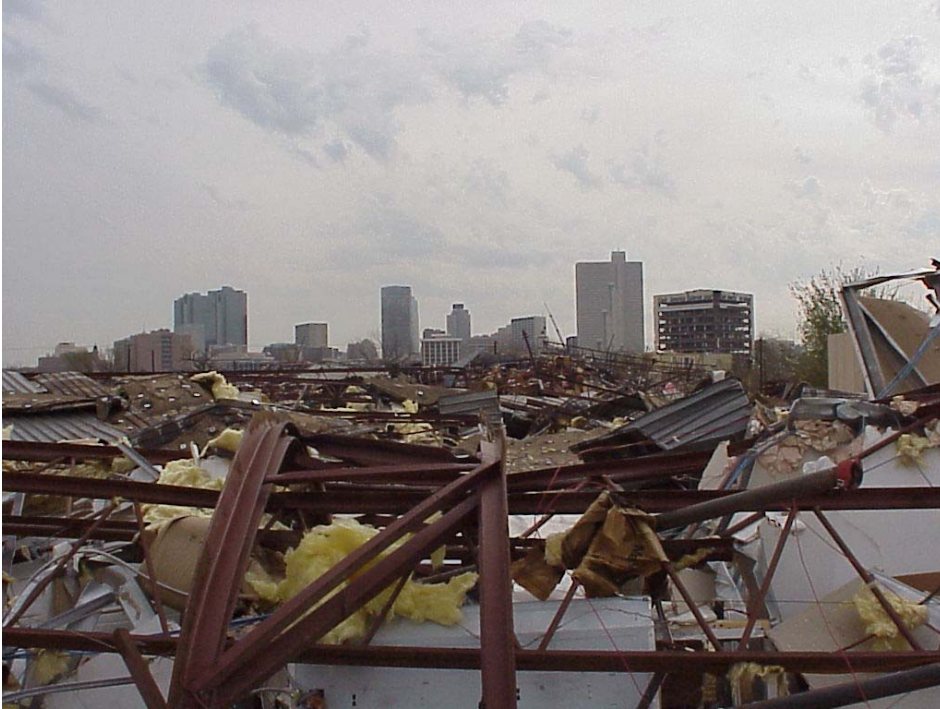
The Sweet Shop Factory lay between Stayton and Harrold Streets, just north of West 6th Street. Constructed of tilt-up concrete wall panels, this building suffered catastrophic failure and generated a large amount of debris. Figure 7 shows a schematic of the collapsed state of this building. The debris varied in size and weight from portions of tar covered roofing insulation to full 20'x 2' sheets of metal roofing with the former observed approximately one-half mile to the SSE on the fifteenth floor of Trinity Terrace facing Fournier Street, just south of West 10th Street. The larger roofing sheets were observed on the ground on Fournier Street between West 7th and West 10th Streets and on the seventh floor of Trinity Terrace.

Figure A1. Looking east over Sweet Shop Factory to downtown area.

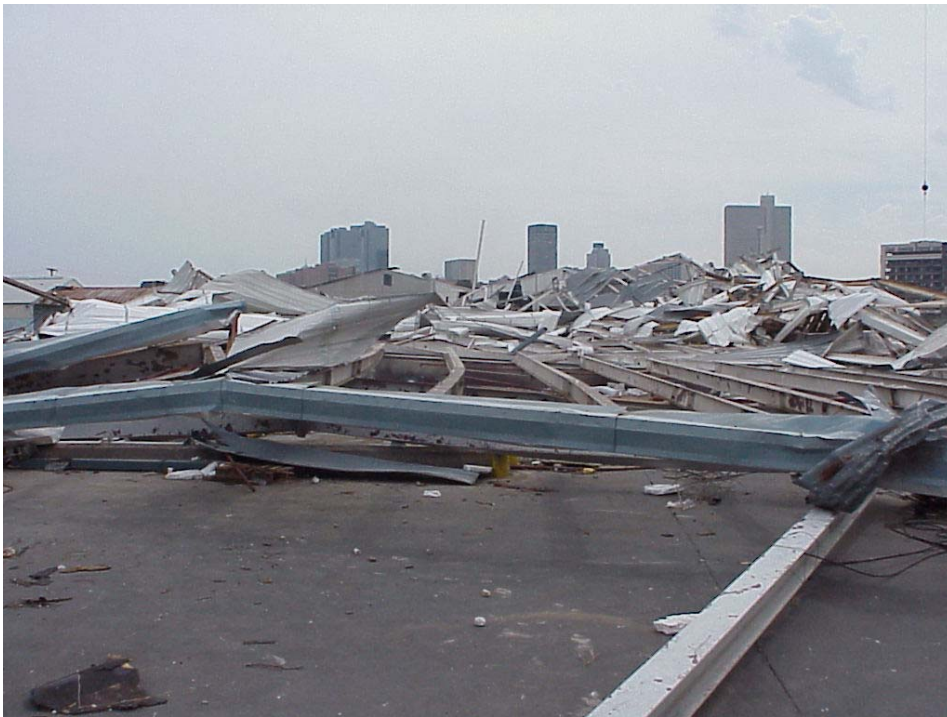
The western half suffered catastrophic collapse, while the eastern end appeared to suffer only loss of roofing. The postulated failure mechanism is as follows:

- The northern wall fell inward to the south and also suffered failure of the column-base connection, this time spalling the concrete plinth. This was most likely a result of the frames falling.

Figure A2. Looking east over Johns Manville warehouse to downtown area.

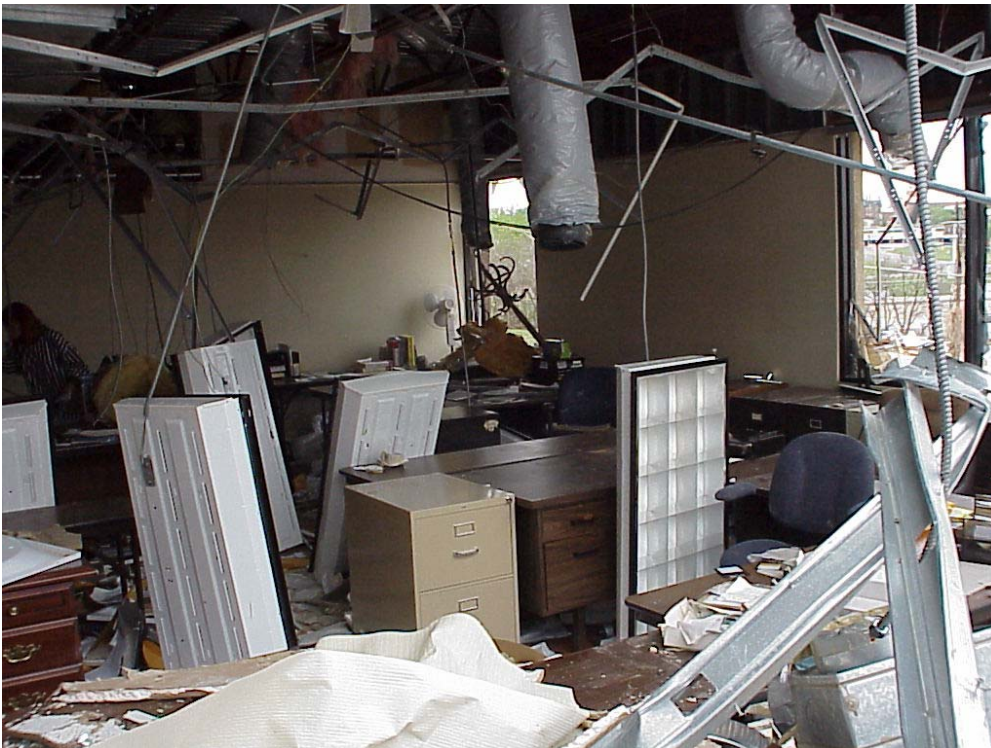
Building Name	Usage	Location	Construction Type	Cladding Damage	Roof Damage	Structural Damage	Evidence of Debris Impact
933 Weatherford	Office	East corner of Lexington & Weatherford	Steel frame precast concrete panels, 2 floors AGL with ground floor open as parking	Severe window damage on SE and SW (~70%) faces	Membrane and insulation completely removed from entire roof. A/C units blown off	Western corner lost roof sheeting and trusses	
Lexington Place	Office	North corner Lexington & 1st	Brick clad precast concrete 4 floors AGL	Windows severely damaged on S corner, SE face NE face has framing removed as well, and window and brickwork blown out on NW face	None, some impact damage to air-conditioning ductwork and equipment.	No	?
Hunter Plaza	Retirement complex	West corner Burnett and 2 nd St	12 floors AGL. U shaped Brick clad opening to SW	Severe window breakage on all faces within the U facing SW. Older style single glazed casement windows. NE face ~ 40% NW face ~ 40% SW face ~ 85% SE face ~ 85%		None

Figure A16. Inside office in 933 W Weatherford.

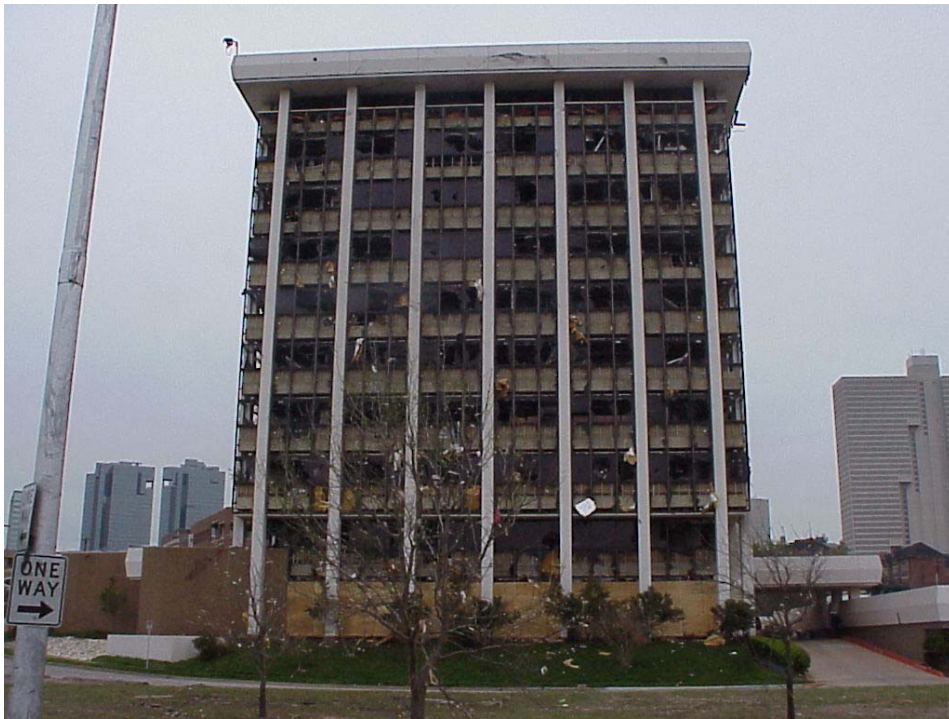
Figure A18. West face of Mallick Tower.

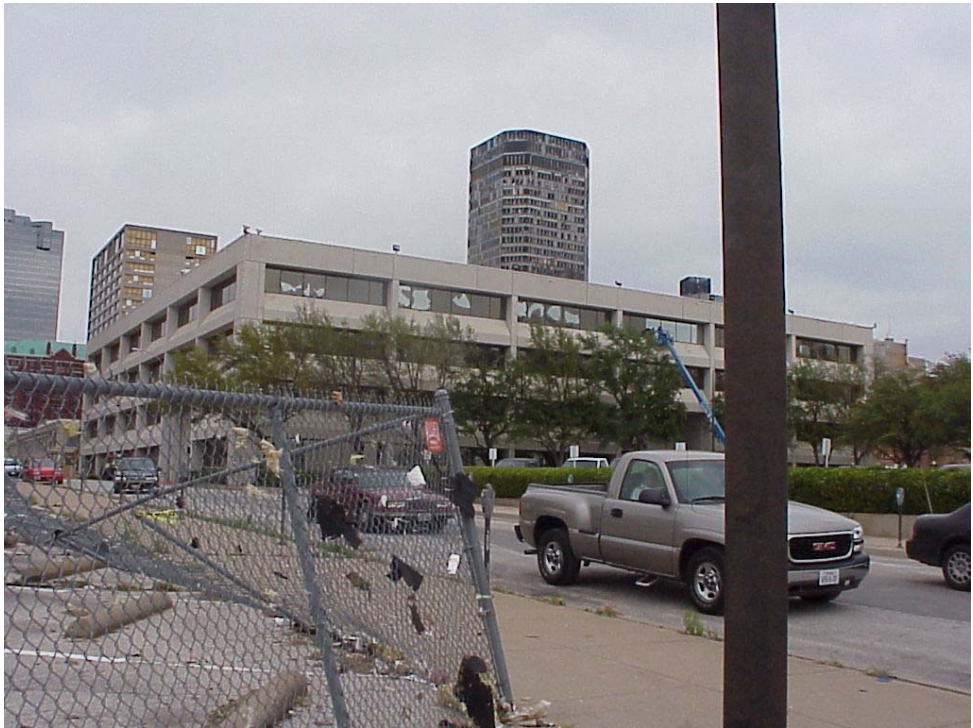
INSpire Insurance	Office	SW side of Burnet between 2 nd and 3rd	Precast concrete panels and glass	Trees along SW face prevented a lot of damage; however, several outer panes of ground level IG units broken as well as windows in the top floor. SW face top floor ~ 80% Roller garage door on NW face blown out.	Skylight broken, evidence of conical roof top vortex removing gravel.	None	Pitted windows

Figure A21. Looking east from Florence and 2nd, INSpire Insurance and Bank One beyond.

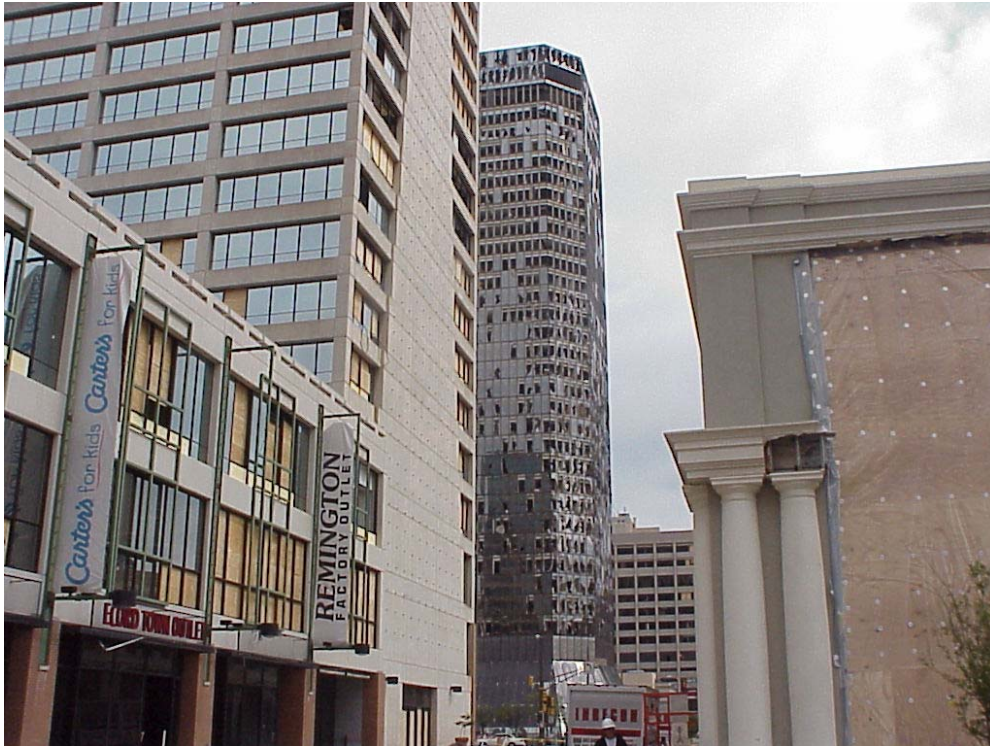
Figure A25. Looking southeast down Taylor, Outlet Mall to left, Library to right and west corner of Bank One in background.

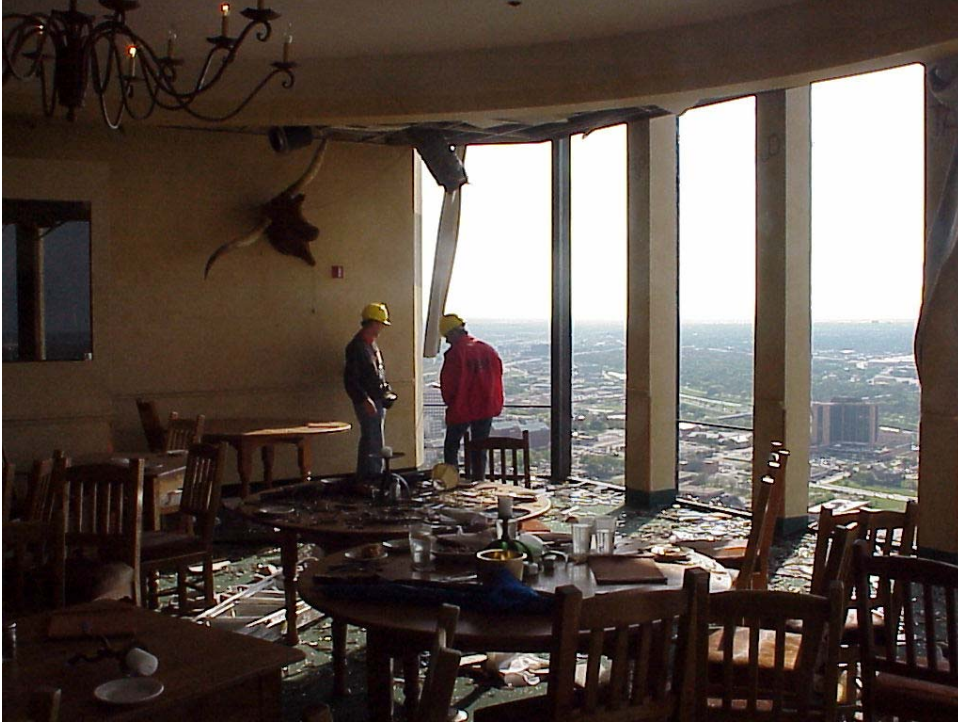
Building Name	Usage	Location	Construction Type	Cladding Damage	Roof Damage	Structural Damage	Evidence of Debris Impact
Bank One Tower	Office	Taylor, 4 th , 5 th & Throckmorton	Glass clad to 35 floors AGL	Extensive damage to glazing N chamfer ? NW face (~60%) W chamfer (~100%) SW face (~90%) S chamfer (~40%) SE face (~15%) E chamfer (~20%) NE face (~40%)	?	no	Many broken windows
Union Pacific Resources Tower (UPR)	Office	Main, Commerce, 6th & 7th	Glass clad to 38 floors AGL	Extensive damage to glazing NE face (~0%) N face Lites (~1%) Spandrels (~10%) NW face Lites (~1%) Spandrels (~5%) SW face Lites (~65%) Here only 30% had both panes of IG unit broken Spandrels (~95%) S face Lites (~35%) Spandrels (~25%)	?	no	Yes, only outer panes broken on many IG units on SE face
City Center Towers	Office	Two towers on eastern & western corners of Commerce and 2 nd	Glass clad to 40 floors AGL	Each Tower similar with W face (~8%) S face (~8%) Negligible damage on N and E faces	?	no

Figure A27. Inside top floor restaurant of Bank One looking southwest.
